## CLICK OF DEATH OR HEAD CRASH

### **DOCUMENTATION VIEWING THE RESULTS OF A HEAD CRASH**

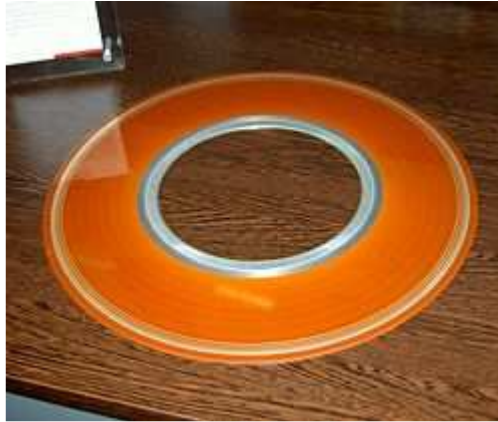
IBM RAMAC disk showing head crash damage

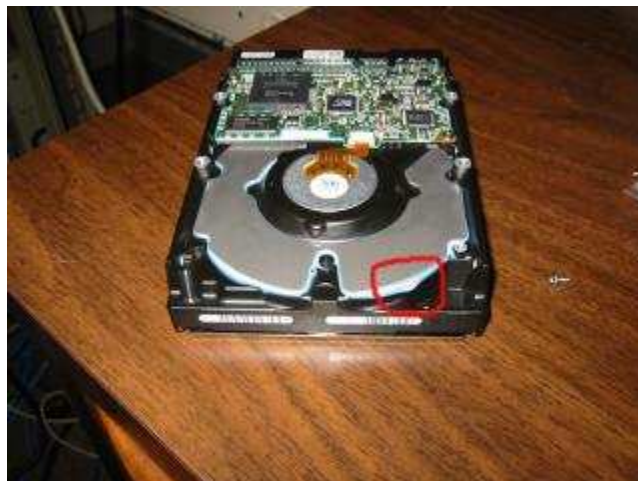
The first thing I noticed was that a blue ooze had seeped out of the bottom of the drive. At this point I was concerned that some of the goo had possibly oozed into the drive housing and onto the platters.

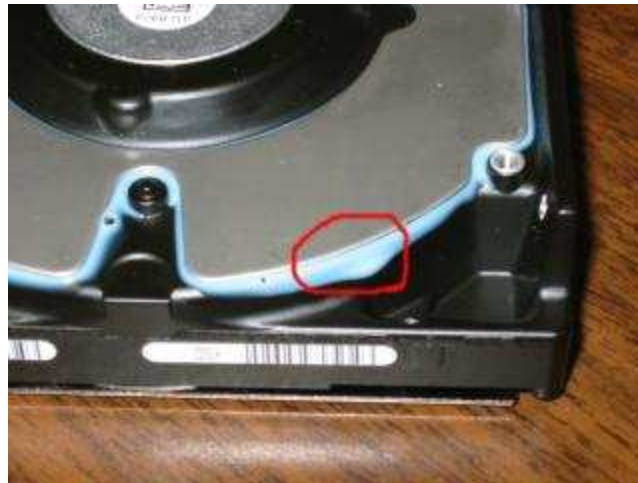
Here is a close-up shot of the drive with the blue goo.

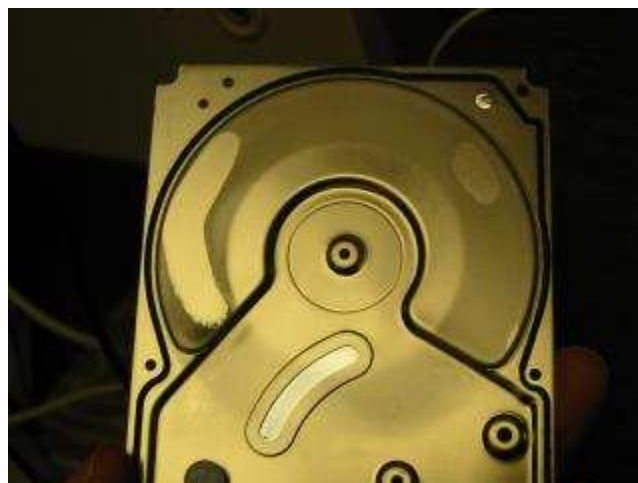
The lid came right off. The first thing we noticed was that there was a large amount of magnetic dust stuck on the lid of the drive. I wiped my finger in one place just to verify that this was not a part of the original manufacture process.

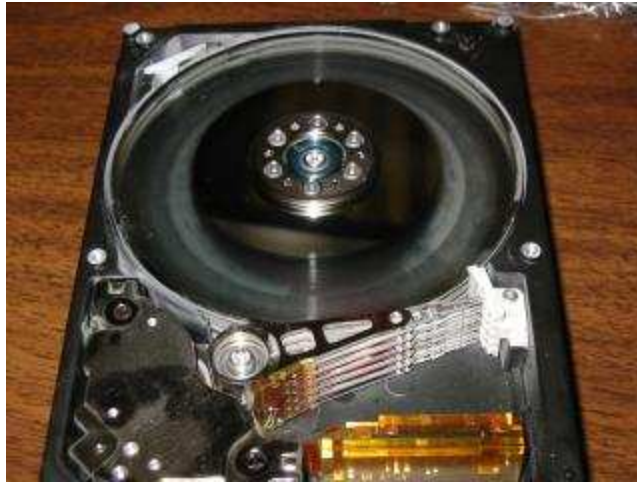
I wondered where all of that dust came from, and then I saw the platters. That's odd, I've never seen see through platters before.

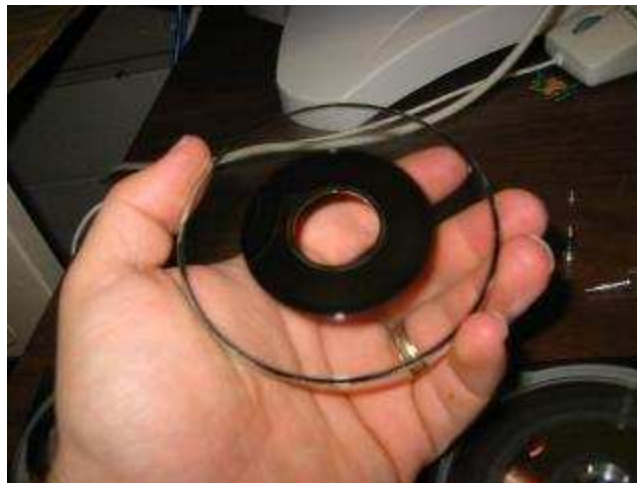
After popping out the first platter I realized that I was correct. The drive platter was now see through. It appears that the head crash scrubbed the drive so clean that the magnetic substrate has been wiped clean off the platters.

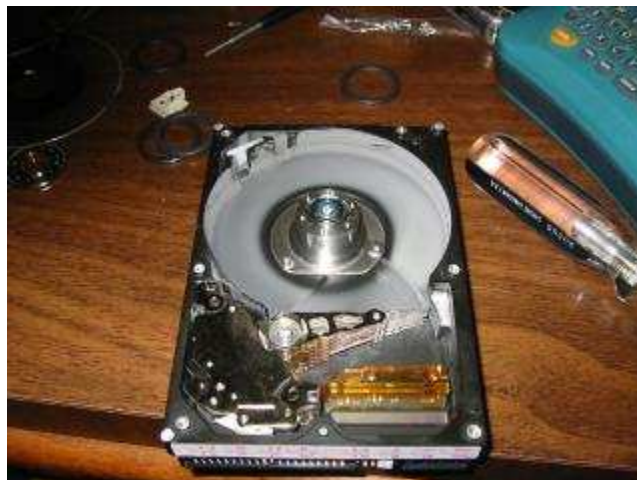
After removing all of the platters from the unit, I noticed that there sure was a large amount of dust inside of the drive housing.

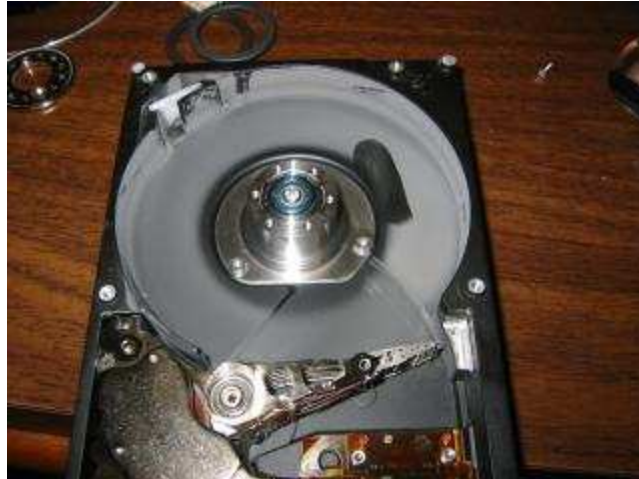
Here's another close-up of the inside of the drive housing. I had wiped my finger on the inside of the housing before shooting this picture.

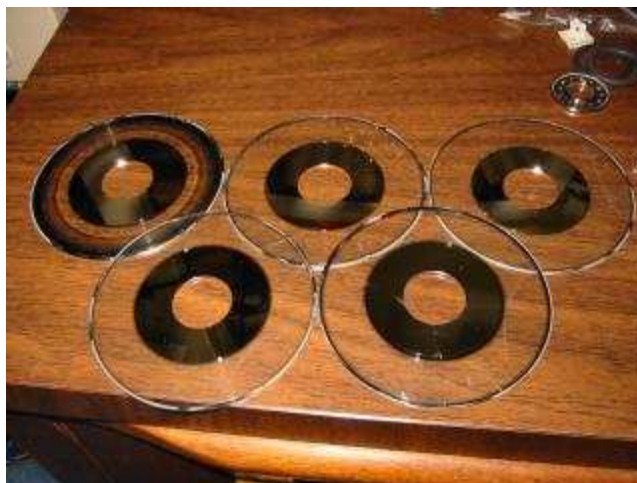
The damage wasn't limited to just one or two platters. All five of the platters received some level of surface wiping.
