## CLICK OF DEATH OR HEAD CRASH

### **DOCUMENTATION VIEWING THE RESULTS OF A HEAD CRASH**

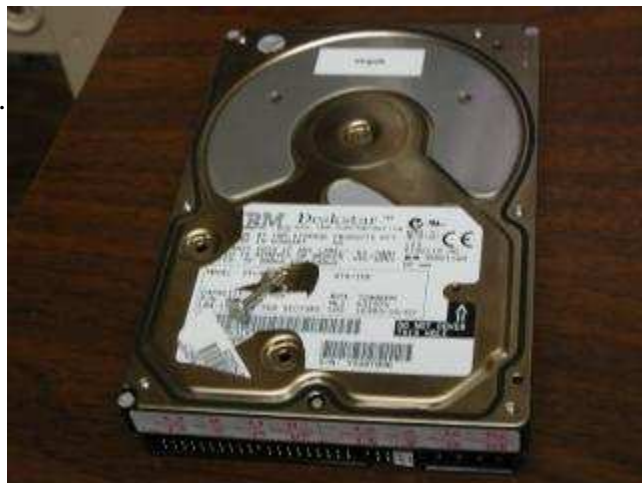
The lid came right off. The first thing we noticed was that there was a large amount of magnetic dust stuck on the lid of the drive. I wiped my finger in one place just to verify that this was not a part of the original manufacture process.
